## State of Utah DEPARTMENT OF NATURAL RESOURCES Division of Oil, Gas & Mining

### Inspection Report Minerals Regulatory Program Penert Date November 16, 2006

Mine Name: Expectation	Permit number: M0350024		
Operator Name: Mark Miller	Inspection Date: October 26, 2006		
·	<b>Time:</b> About 1:30-2:30 PM		
Inspector(s): Paul Baker and Beth Ericksen			
Other Participants: Francisco (trackhoe operator)			
Mine Status: Active	Weather: P	Partly cloudy, 40's	
<b>Elements of Inspection</b>	Evaluated	Comment	Enforcement
1. Permits, Revisions, Transfer, Bonds	$\boxtimes$	$\boxtimes$	
2. Public Safety (shafts, adits, trash, signs, highwalls)			
3. Protection of Drainages / Erosion Control			
4. Deleterious Material			
5. Roads (maintenance, surfacing, dust control, safety)		$\Box$	
6. Concurrent Reclamation	Ħ		
7. Backfilling/Grading (trenches, pits, roads,			
highwalls, shafts, drill holes)			L_j
8. Water Impoundments			
9. Soils	Ħ	Ī	
10. Revegetation	$\boxtimes$	$\overline{\boxtimes}$

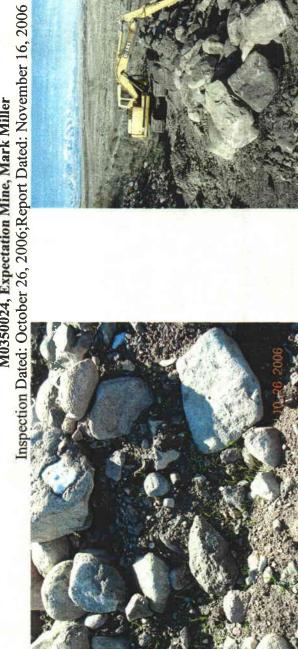
There are two areas I though had been seeded. One is on the west side of the permitted area and the other is a hillside below the power lines (Photo 4). It appears only the area on the west was seeded. We saw numerous grass seedlings in this area (Photo 1), and while there is some cheatgrass, most of the grass appears to be other species, probably those that were seeded.

Photo 1. Grass seedlings in one of the regraded areas.

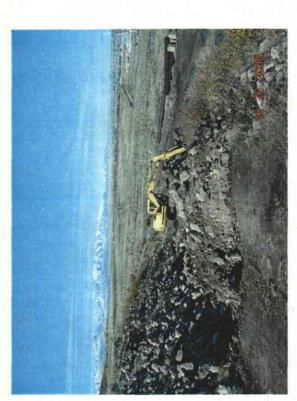
While we were at the site, a trackhoe was digging next to one of the roads accessing the mine site from the north (Photos 2 and 3). We did not see any of the rock being hauled away, but it appeared to

us that the operator was digging rock. This activity was being done outside the permitted disturbed area.

Photo 2. Trackhoe operating along a road north of the mine.

Because the operator was mining outside the permitted area, I issued cessation order MC2006-03-13-01 for failing to conduct operations as shown in the Notice of Intention to Commence Small Mining Operations (NOI) and for failing to maintain adequate surety. This cessation order was issued October 30, 2006.

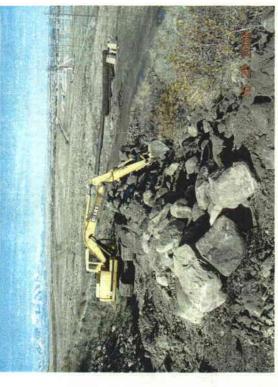
Photo 3. Another view of the area in Photo 2. It appeared the operator was digging rocks.

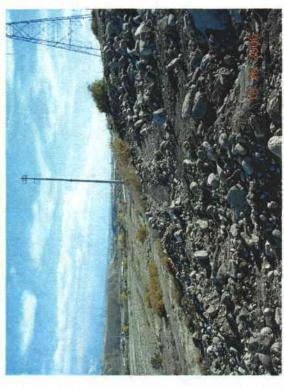
Photo 4. An area below and east of the power lines. It does not appear this area was seeded.

On November 14, 2006, I discussed the bonding requirement with the operator and agreed that if all unpermitted disturbed areas could be seeded, cessation order MC2006-03-04-01 could be modified to simply require the seeding and it could then be terminated.
